**Title of Item:** Mississippi River Diversion Channel Repair Report

## Mississippi River Diversion Channel Inlet Grouted Riprap Repair

### Narrative of Work Completed:

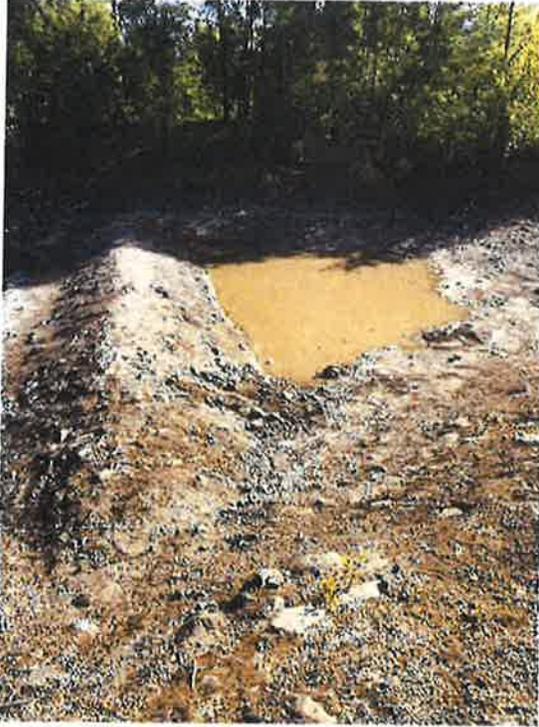
Before:

## Downstream Riprap Weir

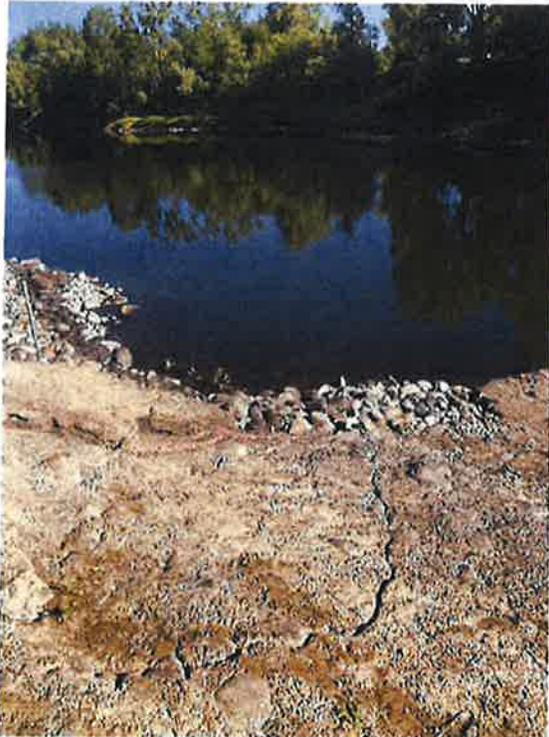
Before:

## Southwest Corner of Spillway

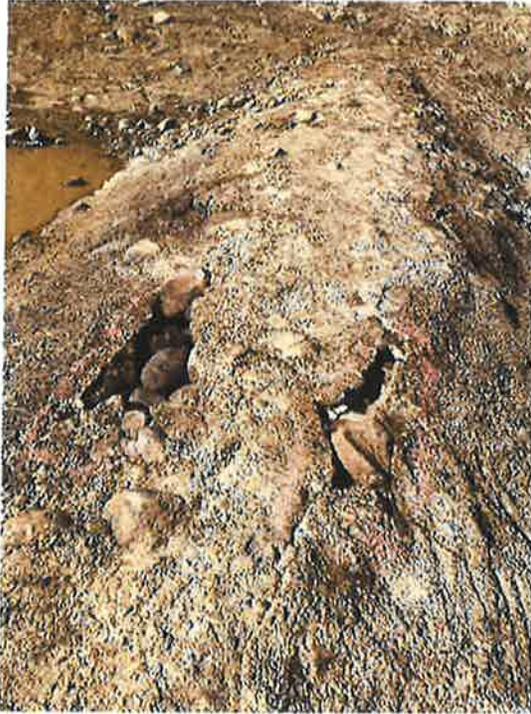
Before:

### Downstream Riprap Weir Looking South

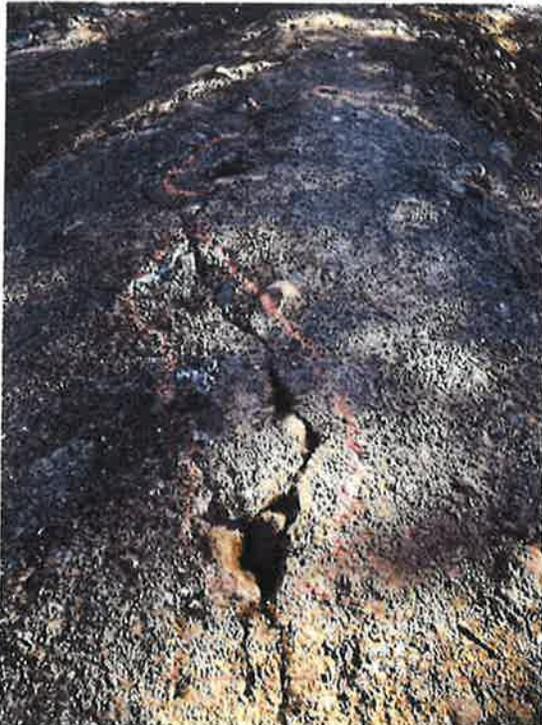
Before:

### Downstream Riprap Weir Looking North

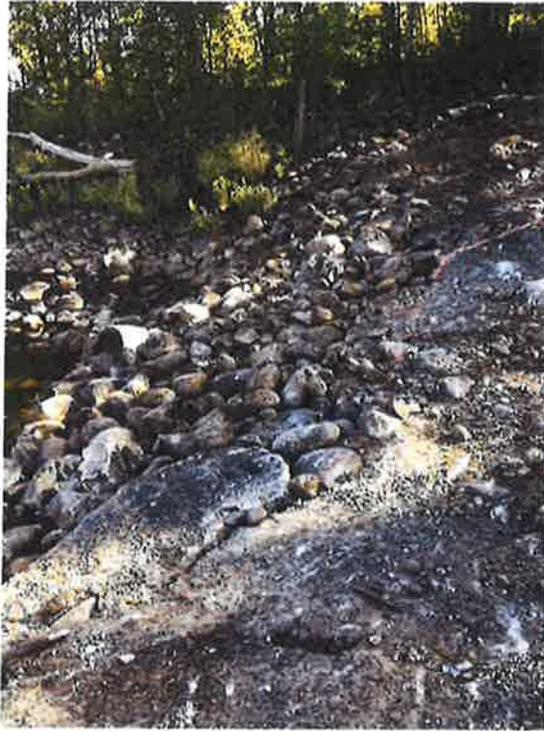
Before:

## Northwest Corner of Spillway

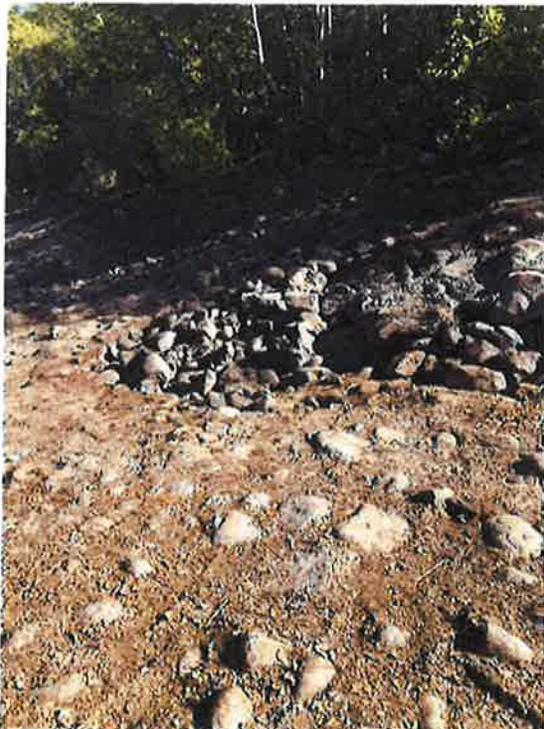
Before:

## North Slope of Spillway

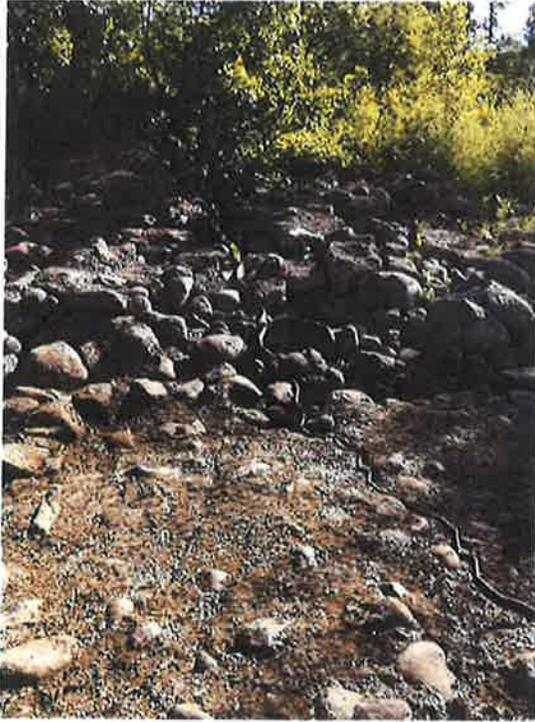
Before:

### Northeast Corner of Spillway

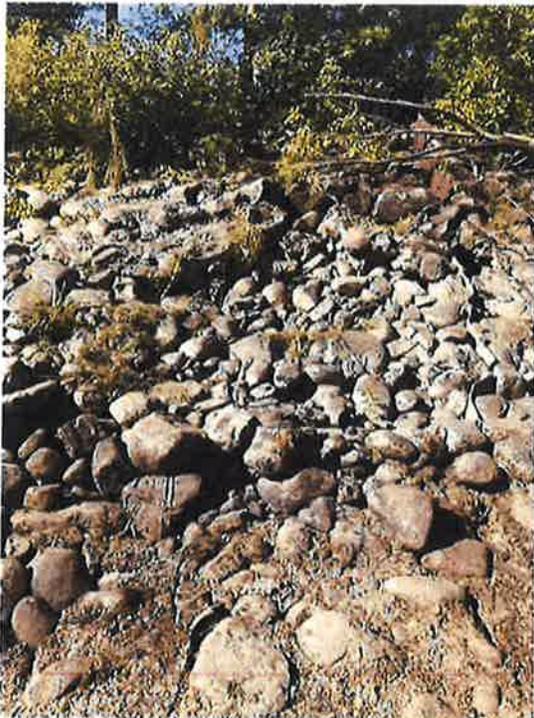
Before:

### Southeast Corner of Spillway

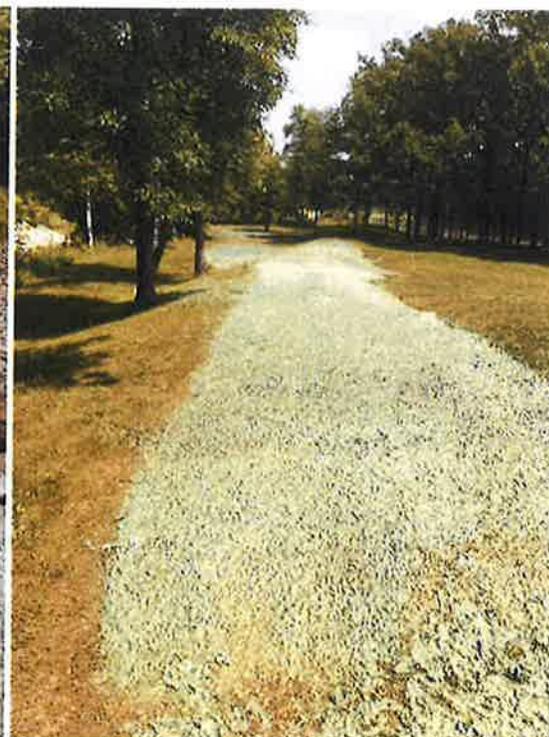
Flood Dike Restoration:
